Socio-Economic Impact of Riverbank Failure at Kg. Pohon Celagi in Pasir Mas, Kelantan, Malaysia

SEE TOO KAY LENG, MOKHTAR BIN JAAFAR, FRANKIE MARCUS ATA* & MOHD RIDHUAN BIN MOHD JAMIL

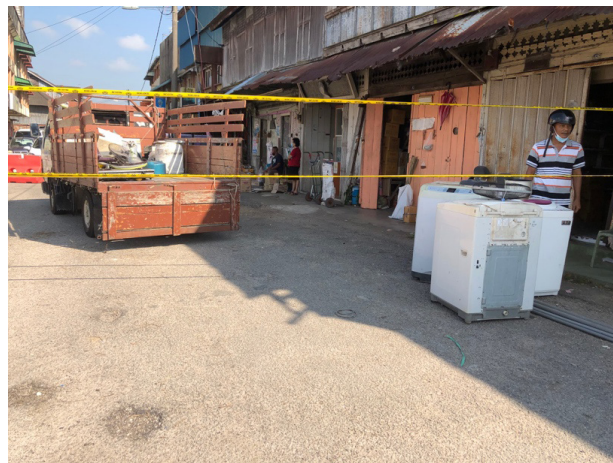
The monsoon season on the Eastern Coast of Peninsular Malaysia occurs from November to February. Generally, the average rainfall amount during the monsoon is between 1500 mm and 2000 mm. The state of Kelantan is on the East Coast experienced more serious rainfall events, specifically in February 2021, which affected the morphology and community settlements along the Kelantan River, particularly in Kampung Pohon Celagi, Pasir Mas. The village experienced a serious riverbank failure on 17 February 2021, which resulted in the loss of homes, damaged roads and agricultural land (Department of Drainage and Irrigation, DID, 2021) (Figure 1).

FIGURE 1. Local Community Moving to Safer Locations

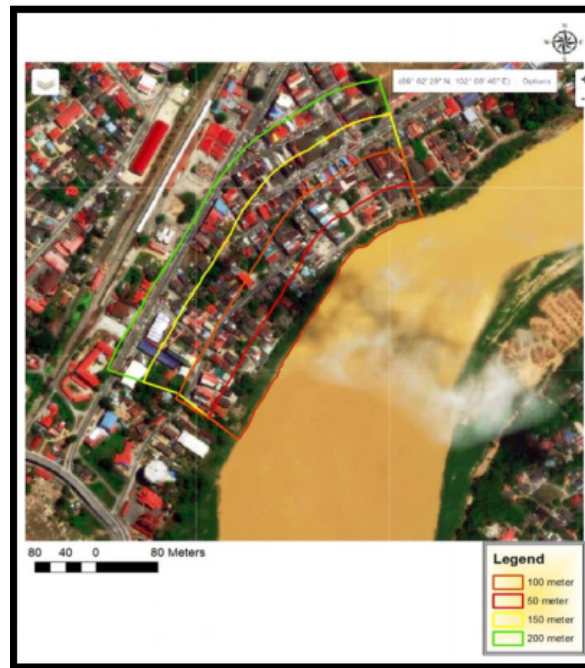
The UAV data demonstrated that the soil movement persisted from day 1 until day 23 when the movement stopped and no new building cracks were detected. During the early stage of the disaster (riverbank collapsed 1-5 meters), the bank movement was relatively swift and could or even be felt when the researchers were in the high-risk zone (see Figure 3).

FIGURE 3. Affected Area

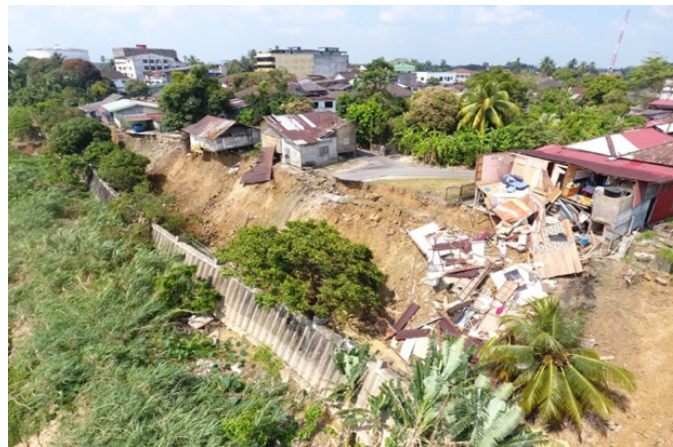
range. Figure 4 depicts the 11 houses affected in the red zone. The investigation discovered that a car had collided with the unstable riverbank.

FIGURE 4. Failed Houses and Sheer Pile

rains. Hence, the concrete sheer pile at the research area failed due to the morphological impact.

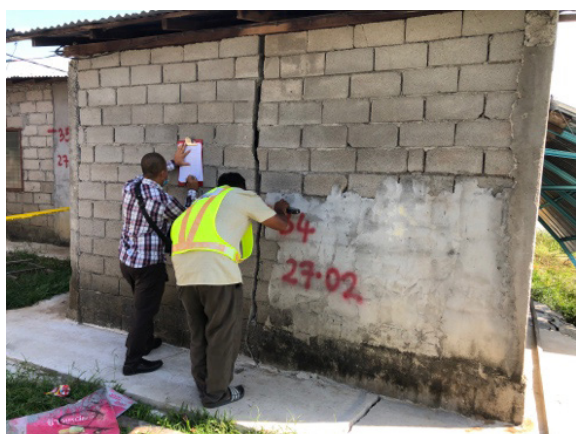
Movement was identified by monitoring cracking on building walls (see Figure 5). According to DID records, the movement continued each day and numerous fissures developed on the walls or the road nearby. Nevertheless, the damage was not as severe as that in the red zone where the buildings had completely failure. The aforementioned cracks expanded daily until no movement was detected on day 23. The DID representative was concerned if the movement would continue or if there would be any future changes as it could not be confirmed whether the soil structure was sufficiently strong to support construction.

FIGURE 5. Measurement of a Cracked Wall
