## Socio-Economic Impact of Riverbank Failure at Kg. Pohon Celagi in Pasir Mas, Kelantan, Malaysia

SEE TOO KAY LENG, MOKHTAR BIN JAAFAR, FRANKIE MARCUS ATA\* & MOHD RIDHUAN BIN MOHD JAMIL

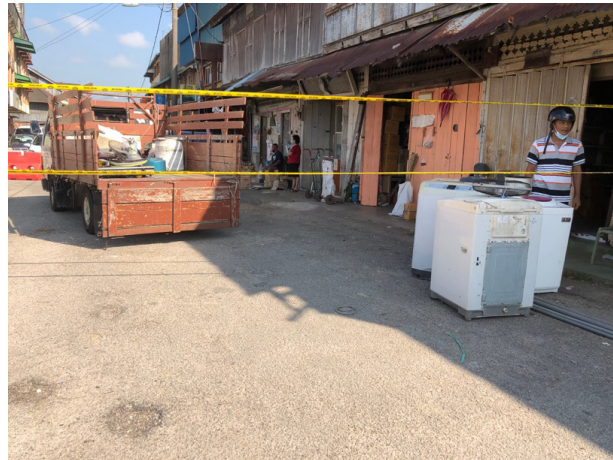
The monsoon season on the Eastern Coast of Peninsular Malaysia occurs from November to February. Generally, the average rainfall amount during the monsoon is between 1500 mm and 2000 mm. The state of Kelantan is on the East Coast experienced more serious rainfall events, specifically in February 2021, which affected the morphology and community settlements along the Kelantan River, particularly in Kampung Pohon Celagi, Pasir Mas. The village experienced a serious riverbank failure on 17 February 2021, which resulted in the loss of homes, damaged roads and agricultural land (Department of Drainage and Irrigation, DID, 2021) (Figure 1).

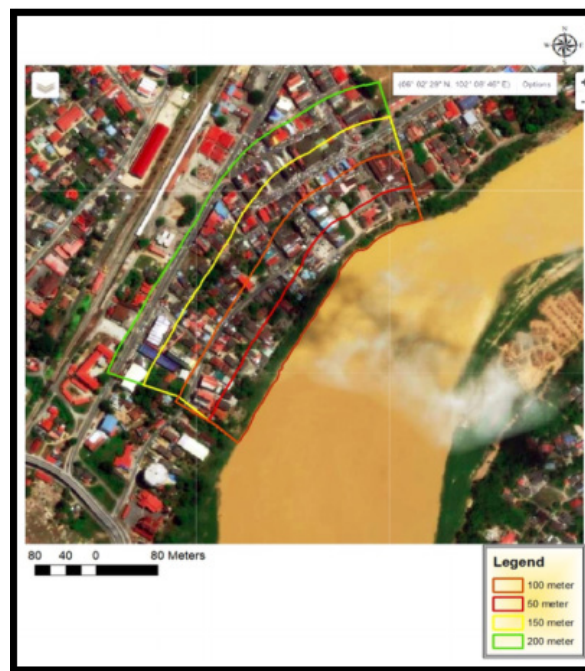
FIGURE 3. Affected Area

The UAV data demonstrated that the soil movement persisted from day 1 until day 23 when the movement stopped and no new building cracks were detected. During the early stage of the disaster (riverbank collapsed 1-5 meters), the bank movement was relatively swift and could or even be felt when the researchers were in the high-risk zone (see Figure 3).

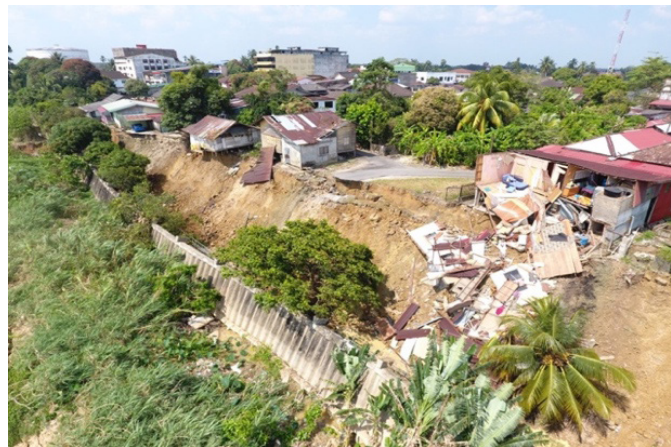
FIGURE 4. Failed Houses and Sheer Pile

range. Figure 4 depicts the 11 houses affected in the red zone. The investigation discovered that a car had collided with the unstable riverbank.

In the red zone, three huge riverbank failures occurred within the 23 days. Consequently, the DID encouraged villagers in the red zone to relocate as soon as possible as the quick soil movement might have endangered them. The local administration assisted all impacted persons in finding temporary housing until the federal government approved compensation. Of the 23 dwellings in the orange zone, only five were harmed by the riverbank failure. The afflicted homes had to be demolished while the residents had to relocate to a safer location.

rains. Hence, the concrete sheer pile at the research area failed due to the morphological impact.

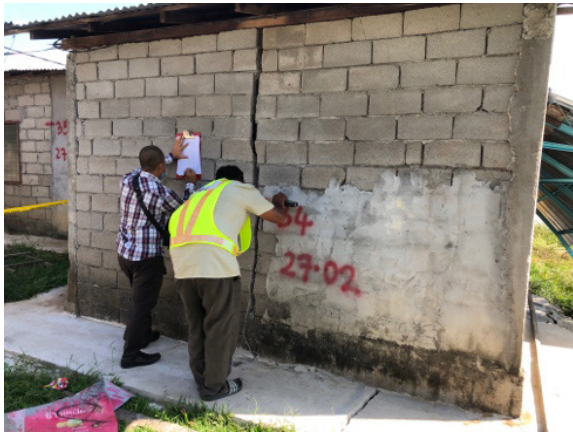
FIGURE 5. Measurement of a Cracked Wall

Movement was identified by monitoring cracking on building walls (see Figure 5). According to DID records, the movement continued each day and numerous fissures developed on the walls or the road nearby. Nevertheless, the damage was not as severe as that in the red zone where the buildings had completely failure. The aforementioned cracks expanded daily until no movement was detected on day 23. The DID representative was concerned if the movement would continue or if there would be any future changes as it could not be confirmed whether the soil structure was sufficiently strong to support construction.
